# Evaluation of Ultra-High Temperature Ceramics for Aeropropulsion Use

NASA Glenn Research Center

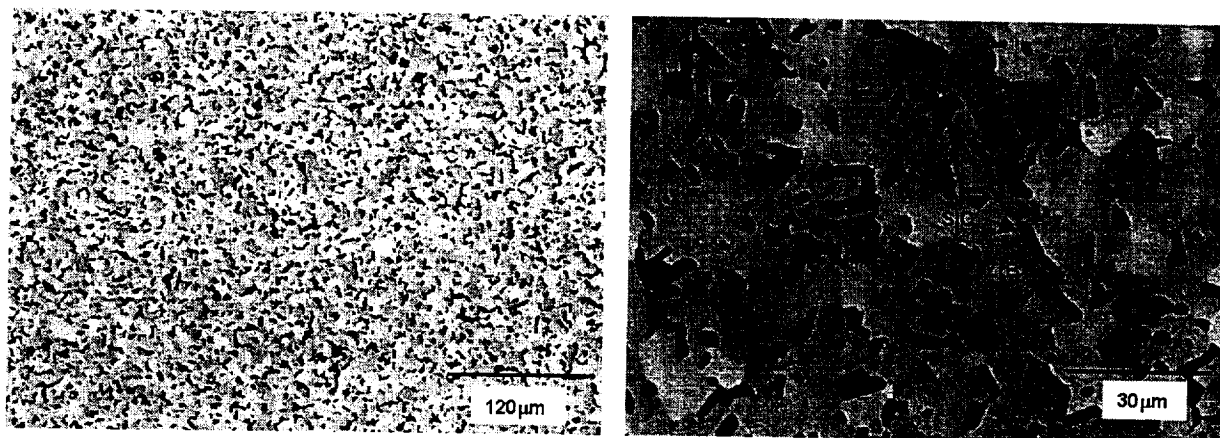
Figure 1. Microstructure of  $\text{ZrB}_2$  plus 20 v/o SiC ultra-high temperature ceramic.

Specimens were mounted in epoxy and polished, then examined via field emission scanning electron microscopy (FESEM) with a Hitachi S-4700 Field Emission SEM with XEDS (X-ray energy dispersive spectroscopy) capability. A representative ZS material microstructure is shown in Figure 1. The  $\text{ZrB}_2$  grains (gray phase) are equiaxed, with the majority of the grains ranging from 6 to  $12 \text{ }\mu\text{m}$  in width. The SiC (dark phase) grains appear to be elongated/tabular (approximately 1.5 to  $3 \text{ }\mu\text{m}$  thick by 3 to  $11 \text{ }\mu\text{m}$  wide/long). ZS was virtually pore-free, and individual large SiC or  $\text{ZrB}_2$  particles (width  $\geq 20 \text{ }\mu\text{m}$ ) that could act as strength-reducing flaws were not observed in the polished

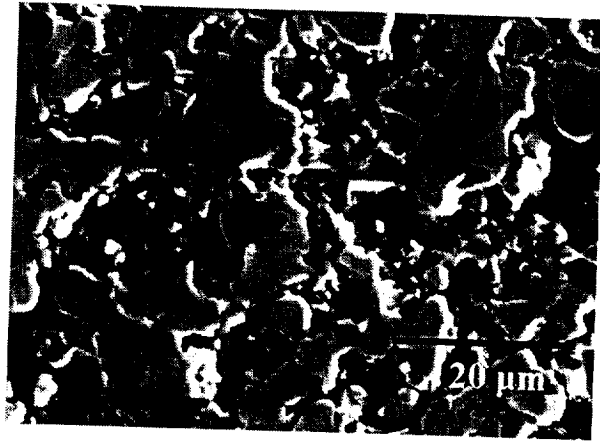
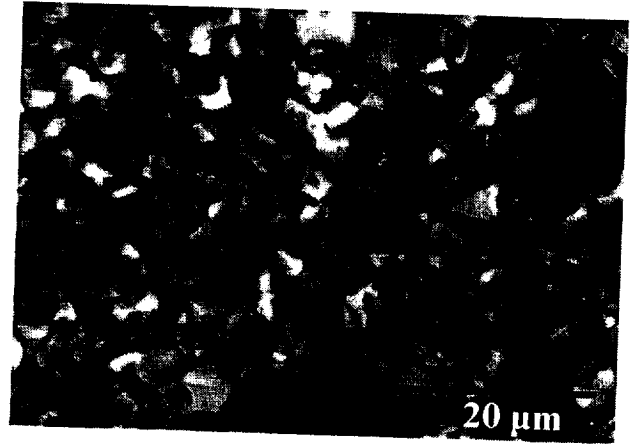
Figure 2. Microstructure of ZrB<sub>2</sub> plus 14 v/o SiC plus 30 v/o C ultra-high temperature ceramic (a) polished section and (b) fracture surface.

cross sections. Significant grain-pullout occurred during the polishing of the ZSC material as shown in Figure 2a. This is attributed to the presence of the 30 volume % C, which apparently led to weaker bonding within this UHTC. For comparison, a ZSC fracture surface is shown in Figure 2b to confirm that the material is close to fully dense.

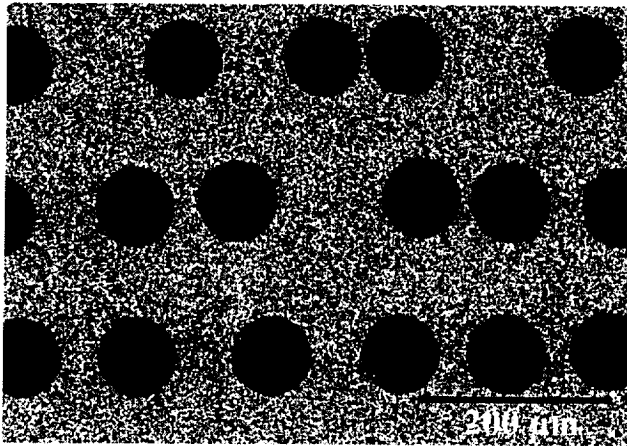
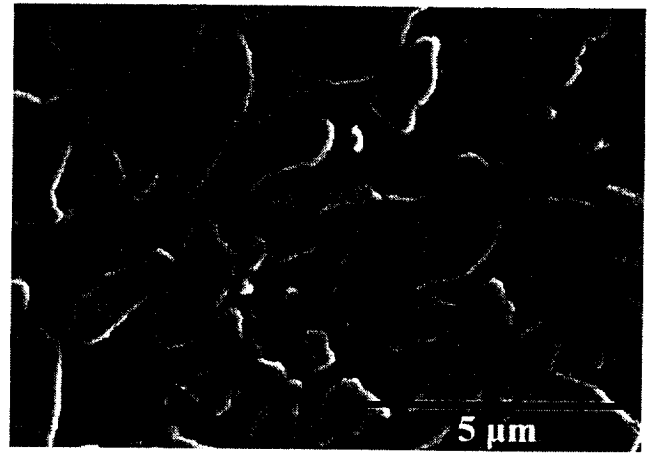
Figure 3. Microstructure of polished sections of  $\text{ZrB}_2$  plus 20 v/o SiC plus SCS-9a fibers composite showing (a) representative fiber distribution and (b) matrix porosity.

The composite panel was prepared by the filament winding and slurry deposition technique followed by hot pressing in a graphite die. The final composite panel was 15.1 by 15.1 by 0.53 cm with a density of 3.47 gm/cm<sup>3</sup>, while the theoretical density is 4.60 gm/cm<sup>3</sup> for 35 volume % fiber loading. ZSS composite specimens were mounted in epoxy and polished, then examined via optical microscopy and FESEM. A representative ZSS composite microstructure is shown in Figure 3a. The SCS-9a fibers have a diameter of about 80  $\mu$ m including the dual layer coating. It appears that the coating on the surface of the SCS-9a fibers remained intact during the hot pressing process. The fiber volume fraction within the multilayer plies was at the target 0.30. However thick matrix layers between plies reduced the overall fiber volume fraction to 0.20 to 0.25. Significant amounts of porosity can be seen in the matrix (Figure 3b). Based on the density of the billet and a rule of mixtures calculation, the matrix material is approximately 70 % dense. Longitudinal sections revealed regularly spaced matrix cracks (400 to 800  $\mu$ m apart) oriented perpendicular to the fibers. These cracks are due to the matrix thermal expansion coefficient being greater than that of the fiber and thus leading to cracking upon cooling from the processing temperature, as is observed in other composites such as C/SiC.

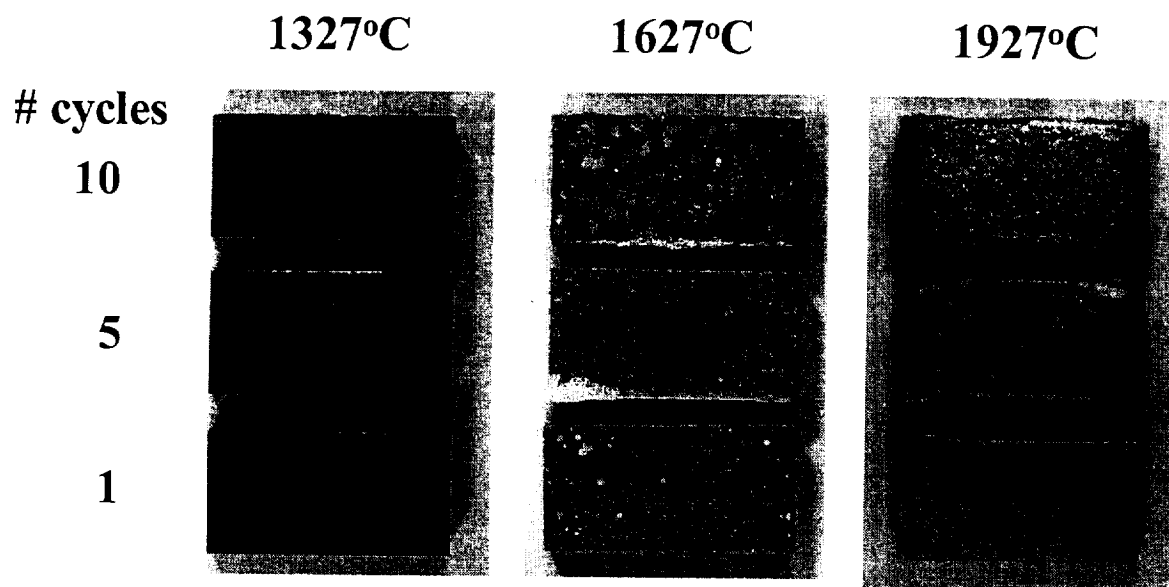
Figure 4. ZS UHTC oxidized in air for 10 minute cycles.

Macrographs of the ZS samples after oxidation are shown in Figure 4. Oxide formation is visible on the samples tested at 1327°C. Extensive glass formation was observed on samples exposed at 1627°C. Samples oxidized at 1927°C formed an orange oxide after one 10-minute cycle. With increasing exposure time, the oxide scale became grayer. At this exposure temperature, swelling of the samples occurred with the thickness of the specimens increasing by up to 80% after ten 10-minute cycles. XRD analyses show the surface oxidation product is largely monoclinic  $\text{ZrO}_2$  under all conditions. An SEM photomicrograph of the surface of ZS after oxidation for one 10-minute cycle at 1327°C is shown in Figure 5. The large white crystals on the surface are  $\text{SiO}_2$  and the irregularly shaped material in the background is a mixture of  $\text{SiC}$ ,  $\text{ZrO}_2$  and  $\text{SiO}_2$ .

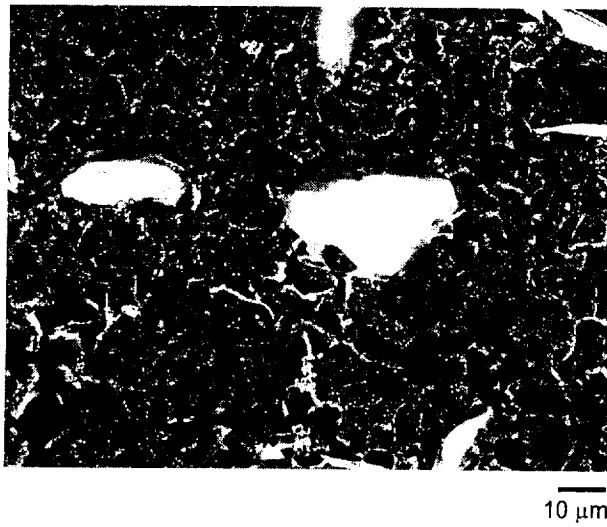
Figure 5. SEM micrograph of ZS after oxidation in air for 10 min at 1327°C.

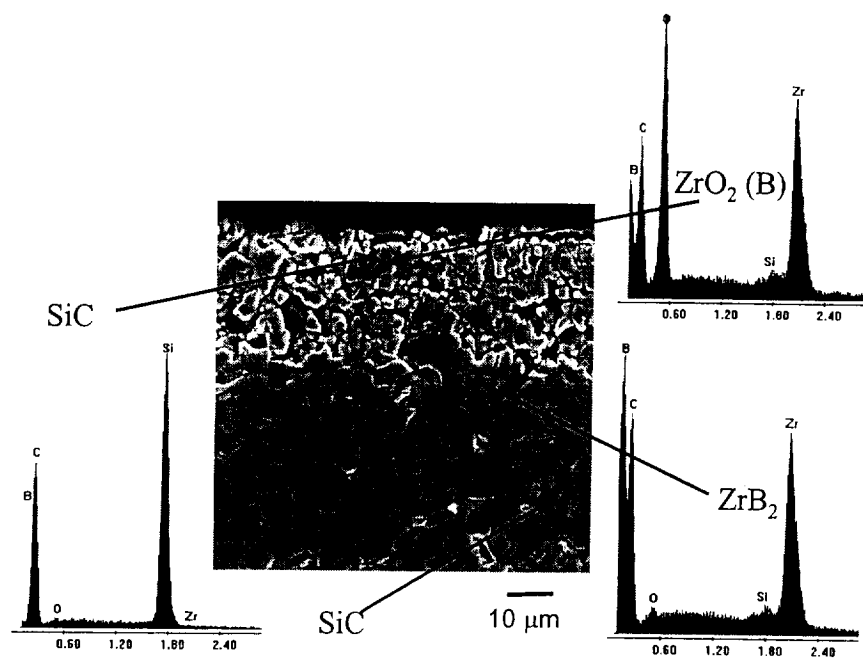
Figure 7. SEM micrograph and EDS analysis of phases in ZS after oxidation in air at 1327°C for ten 10 min cycles.

SEM and XEDS results for ZS sample cross-sections are shown in Figures 7 through 9. SEM and XEDS results were obtained at 6kV where sensitivity to boron is high. After exposure at 1327°C for ten 10-minute cycles, the oxide scale was about 30  $\mu\text{m}$  thick and composed of  $\text{ZrO}_2$  with  $\text{SiC}$  particles embedded in the scale as shown in Figure 7. XEDS analysis of the  $\text{ZrO}_2$  scale in this and all subsequent samples showed some boron content. Figure 8 shows a ZS sample cross-section after exposure at 1627°C for ten 10-minute cycles as well as the results of an XEDS line scan. The oxide scale was about 150  $\mu\text{m}$  thick. Beginning from the surface, the scale was composed of amorphous  $\text{SiO}_2$  followed by a layer consisting primarily of  $\text{ZrO}_2$  in a continuous silica-rich glassy phase. No boron

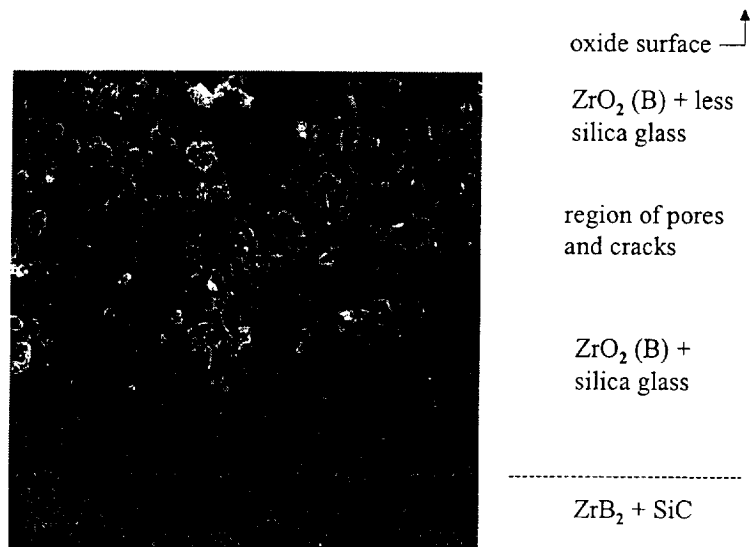
Figure9. SEM micrograph and the results of EDS analysis for ZS after oxidation in air at 1927°C for ten 10 min cycles.

was detected in the glassy phase. A discrete  $\text{ZrO}_2/\text{ZrB}_2$  boundary was followed by a SiC depleted region of  $\text{ZrB}_2$  of about another 100  $\mu\text{m}$  thickness. This SiC depletion layer was observed in previous work, both the work at high temperatures and high oxygen partial pressures<sup>1</sup> as well as in exposures at lower temperatures, but only in reduced oxygen partial pressures<sup>6</sup>. This SiC depletion was attributed to active oxidation of the SiC to form  $\text{SiO(g)}$ <sup>6</sup>. Figure 9 shows the ZS sample cross-section after exposure at 1927°C for ten 10-minute cycles. Here, the oxide scale was several mm thick. The scale was composed of large  $\text{ZrO}_2$  grains in a silica-rich glassy phase. No SiC depletion layer was observed.

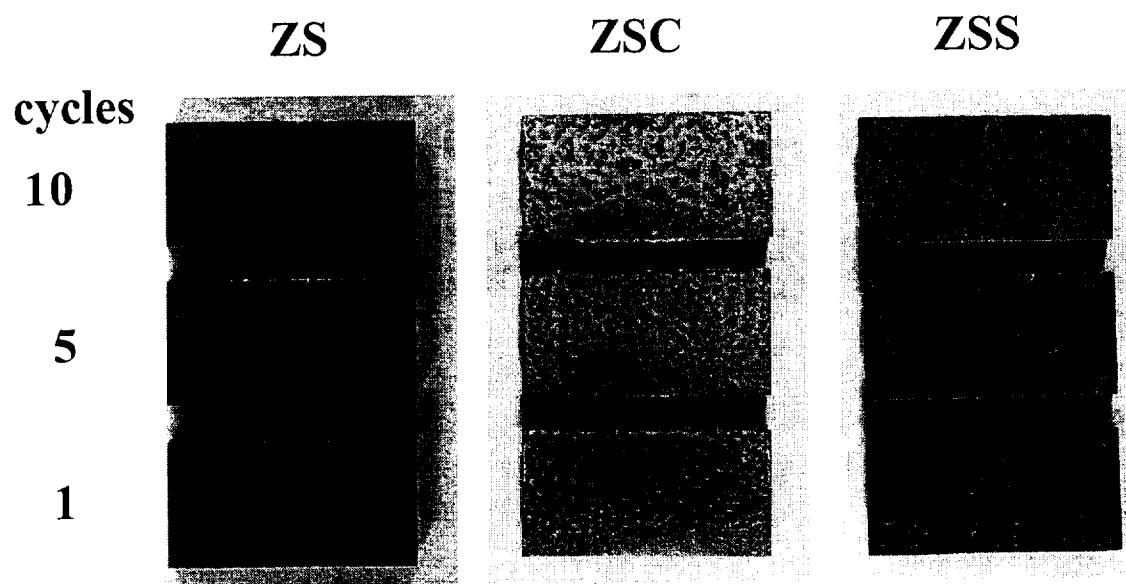
Figure 10. Comparison of UHTC oxidized in air at 1327°C for 10 minute cycles.

Figure 10 shows the surface appearance of the three materials examined in this study after oxidation exposures of 1, 5, and 10 ten-minute cycles at 1327°C. The most compact and homogeneous scale is formed on the ZS formulation. This is supported by the weight change data for ZS and ZSC shown in Figure 11. Weight increases are due to the formation of  $\text{ZrO}_2$ . ZSC oxidizes more rapidly than ZS due to the presence of porosity resulting from the oxidation of C and scale disruption due to CO formation. The weight loss for the SCS-9a fiber reinforced material is in large measure due to the loss of the ~ 10  $\mu\text{m}$  carbon cores of the fibers. Figure 12 illustrates the near parabolic oxidation kinetics exhibited by ZS and ZSC at 1327°C.

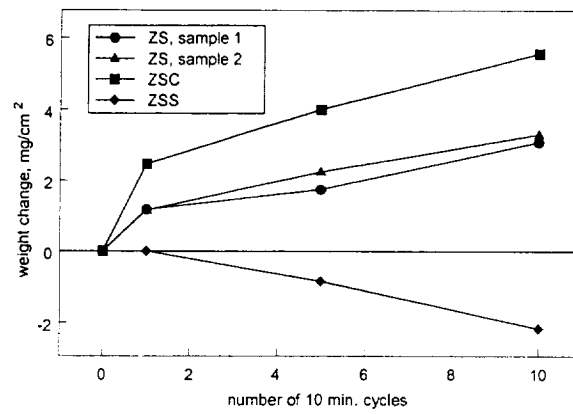
Figure 11. Oxidation behavior of UHTC at 1327°C in air.

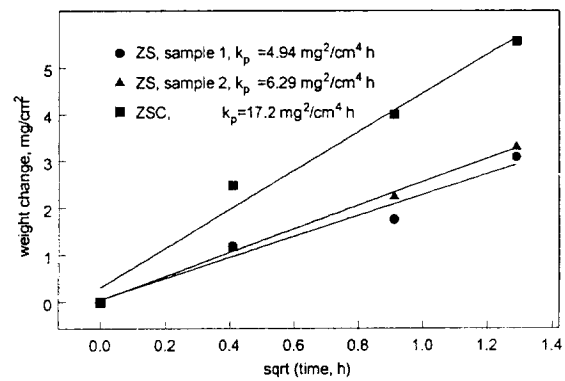
Figure 12. Parabolic oxidation behavior displayed by ZS and ZSC at 1327°C in air.

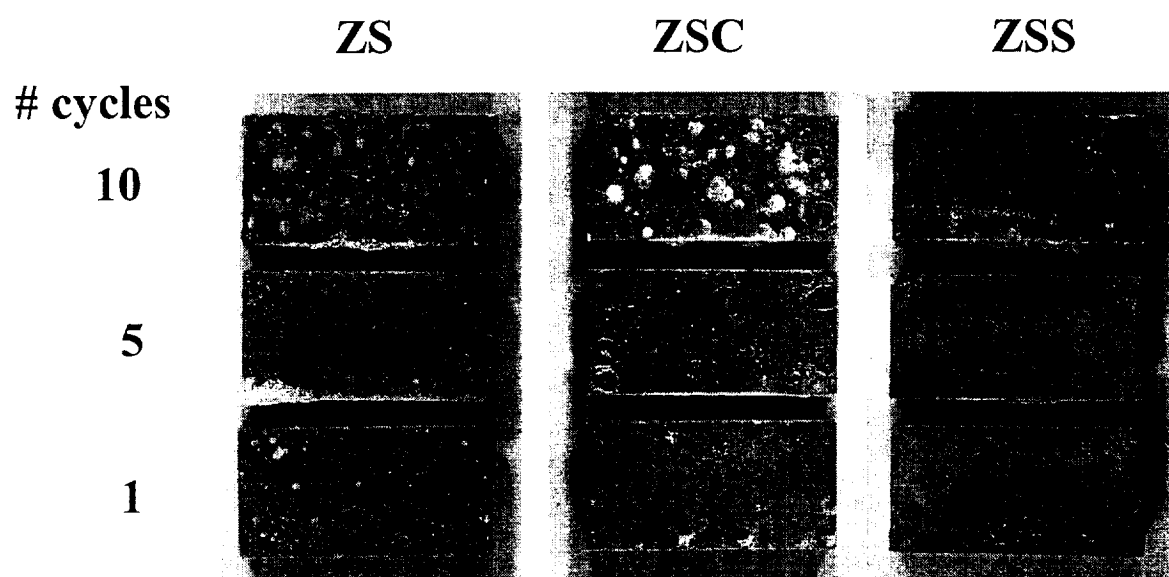
Figure 13. Comparison of UHTC oxidized in air at 1627°C for 10 minute cycles.

Figure 13 shows the surface appearance of the ZS, ZSC, and ZSS materials after oxidation exposures of 1, 5, and 10 ten-minute cycles at 1627°C. The most compact and homogeneous scale is again formed on the ZS formulation. Weight change data in Figure 14 shows near parabolic behavior for ZS, deviation from parabolic behavior for ZSC due

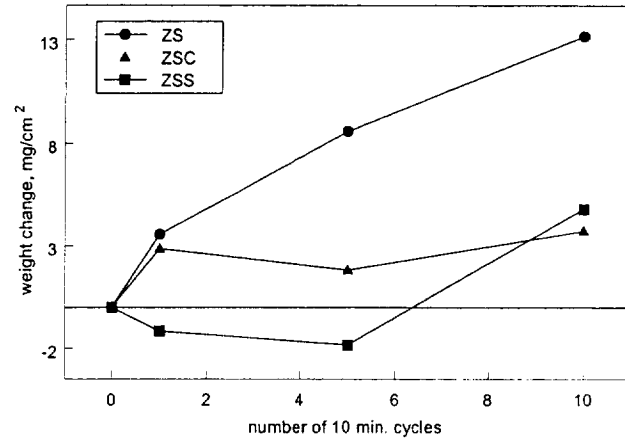
Figure 14. Oxidation behavior of UHTC at 1627°C in air.

to scale spallation, and a recovery from the weight loss of fiber carbon cores in ZSS as a result of the rapid kinetics of oxidation of the porous matrix to form  $\text{ZrO}_2$ .

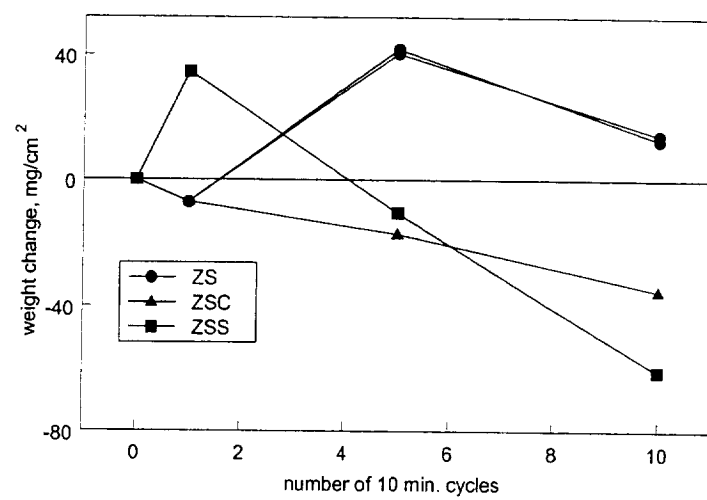
Figure 16. Oxidation behavior of UHTC at 1927°C in air.

Figure 15 shows the surface appearance of the three materials examined in this study after oxidation exposures of 1, 5, and 10 ten-minute cycles at  $1927^\circ\text{C}$ . Extensive distress in the form of cracks, nodules, and spallation is evident in the scales on all three materials. ZSS was severely bloated as a result of oxidation. The weight change plots in Figure 16 are indicative of this distress with parabolic behavior no longer evident in ZS, and large weight losses evident at 5 and 10 cycles in ZSC and ZSS.

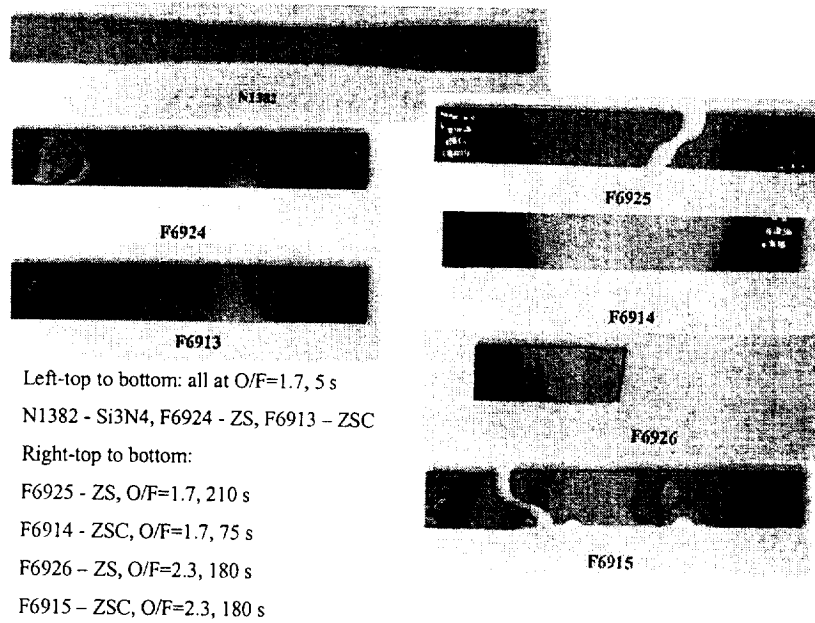
Figure 17. Photographs of specimens tested in thermal shock.

Results of thermal shock tests are summarized in Figure 17 and Table 5. One of two ZS samples survived 5 s exposures at O:H of 1.7, as did a ZSC and the AS-800 sample. Other tests of AS-800 resulted in survival of hundreds of cycles (A.E. Eckel, private communication). The AS-800 sample appeared to oxidize to a lesser extent than the

UHTCs. ZSC oxidized to a greater extent than ZS. Longer duration exposures at O:H of 1.7 resulted in more extensive oxidation and, in some cases, erosion. In most cases the samples fractured. At the higher O:H of 2.3, samples of each UHTC material were severely eroded after 180 s of exposure.
